P/N: 902387-1, Rev. G

NSN: 1620-00-821-5265

# P-3 Nose Gear Drag Strut Assembly Upgrade

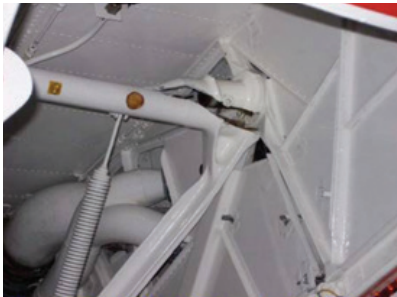
Before

The P-3 Nose Gear Drag Strut is prone to hidden corrosion and fatigue cracks which can lead to fracture and potential nose gear collapse. It is in service with launch customer Royal Australian Air Force. We have partnered with Snowline Aerospace, Inc., to manufacture replacement struts to prevent possible gear collapse. These are U.S. Navy approved direct replacements.

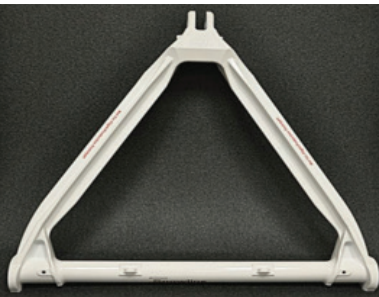
After

<b>Drag Strut Material</b>	Use of 7050-T7451 aluminum plate is more corrosion resistant than the 7049 forging
<b>Drag Strut Coatings</b>	Change to an anodized finish per Mil-A-8625, Type III, Class 1, .001 thick
<b>Drag Strut Bushings</b>	Material change to aircraft alloy 8620. Typical uses for this alloy are gears, ring gears, shafts and crankshafts

- » High-Grade machined aluminum verses traditional forging
- » Load stress points re-distributed to minimize structural stress
- » Robust design and specialized material to resist corrosive environment
- » Lockheed Martin Certified Parts Provider approved
