P/N: 902387-1, Rev. G

# P-3 Nose Gear Drag Strut Assembly

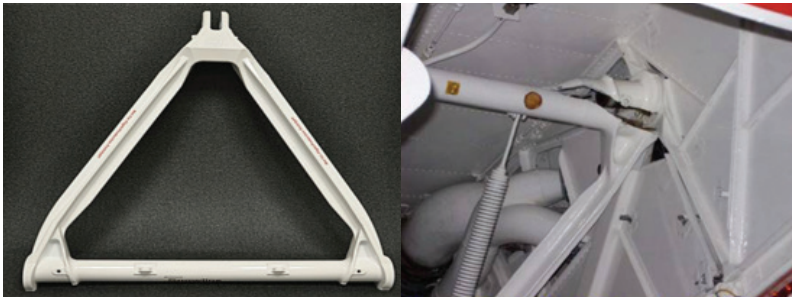
The P-3 Nose Gear Drag Strut is prone to hidden corrosion and fatigue cracks which can lead to fracture and potential nose gear collapse. It is in service with Royal Australian Air Force. We have partnered with Snowline Aerospace, Inc., to manufacture replacement struts to prevent possible gear collapse. These are direct replacements.

<b>Drag Strut Material</b>	Use of 7050-T7451 aluminum plate is more corrosion resistant than the 7049 forging
<b>Drag Strut Coatings</b>	Change to an anodized finish per Mil-A-8625, Type III, Class 1, .001 thick
<b>Drag Strut Bushings</b>	Material change to aircraft alloy 8620. Typical uses for this alloy are gears, ring gears, shafts and crankshafts

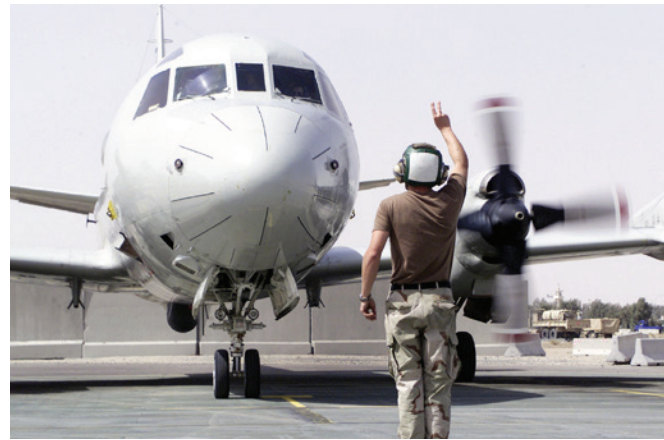
The results of this study show that with the given set of parameters defined in the "Linear Static Extension Study" the drag strut would not begin to see any fatigue failures until well after 200,000 cycles.
